CHEROKEE SILT FENCE COMPANY, INC.

Holly Commons Subdivision

In Water Treatment

Holly Springs, GA Spring 2006

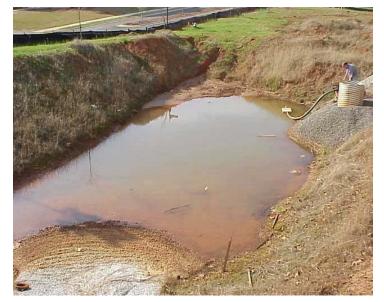
The sediment had been given time to settle out, leaving only very fine particulate suspended in the pond

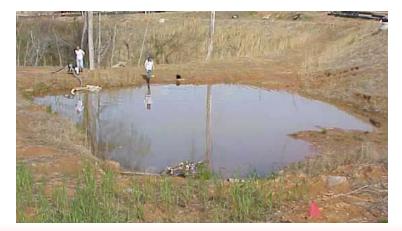
Around the ponds was mostly bare soil with no temporary grassing

The slopes were then hydroseeded with seed, fertilizer and Silt Stop powder. The polymer helps to stabilize the slope and keep the seed and fertilizer from washing away until the grass has a chance to germinate. The areas of bare soil that were not hydroseeded were sprinkled with dry Silt Stop powder and covered with straw to help stabilize them.

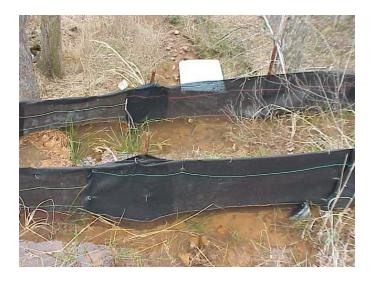
The water running off the jute fabric and through the silt fence is clear water measuring 15 NTU.

The jute matting was sprinkled with APS 712 Silt Stop powder to enhance the particle collection, and the jute matting was run all the way down the hill to the double row of silt fence just above the creek. The plastic sheeting in the ditch prevented the highly erosive fill soil from being carved out and carried away by the water in the ditch. The Silt Stop treated jute matting protected the soil going down the slope, as the matting stuck to the soil surface and prevented it from washing away.

The second pond was smaller, containing only 10,000 gallons of water, but had more turbid water, with an initial reading of 850 NTU. It was pumped out at the same rate, with a final turbidity reading of 15 NTU. This is greater than a 98% turbidity reduction.

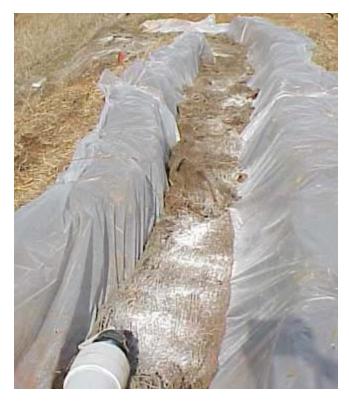
The ditch was made with two rows of straw bales covered with plastic and lined with two layers of an open-weave jute matting sprinkled with the appropriate Silt Stop_® powder.

The first step was to pump the water out of two of the small sediment ponds. APS 703d and APS 706b Floc Logs were used together to treat the suspended sediment in the water as it was pumped out of the pond, clarifying the water enough that it could be discharged directly into the nearby creek. The Floc Logs were placed into static mixers attached to the pump, so the water was pumped out of the pond and mixed with the polymer logs before being discharged into the ditch. The treatment ditch was constructed across a flat area, using straw bales and lined with plastic sheeting and a couple of layers of jute matting. The suspended sediment binds together after reacting with the Floc Logs and then sticks to the jute matting, leaving clean water exiting the ditch and flowing into the creek.
