Applied Polymer Systems, Inc.

Innovations

In Soil Stabilization

US Highway 98 Summer 2005

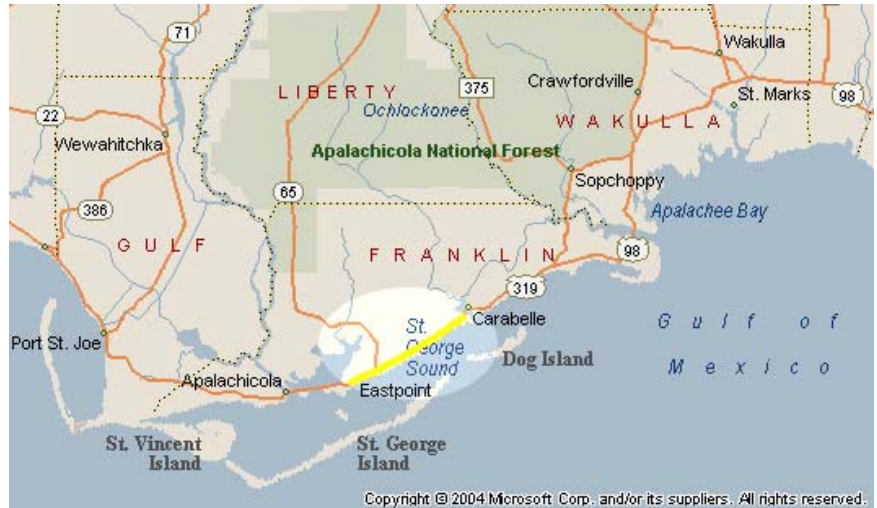
This 14 mile stretch of Highway 98 along the coast was the project area.
